Navajo Abandoned Uranium Mine

Site Screen Report

Juan Horse No. 4 AUM Site

Navajo AUM Northern Region

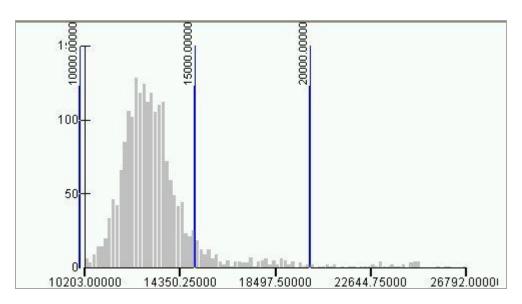
The following chart and statistics were generated by ESRI ArcGIS 9.3.1, and show the general distribution of the site gamma radiation measurements. The horizontal X axis represents the gamma radiation reading levels in cpm (lowest levels to the left). The vertical Y axis represents the frequency of each gamma radiation level.

Count:
 1999

Minimum:
 10203.00000

Maximum:
 26792.00000

Mean:
 13377.79390

Median:
 12983.00000

Standard Deviation:
 2060.73314

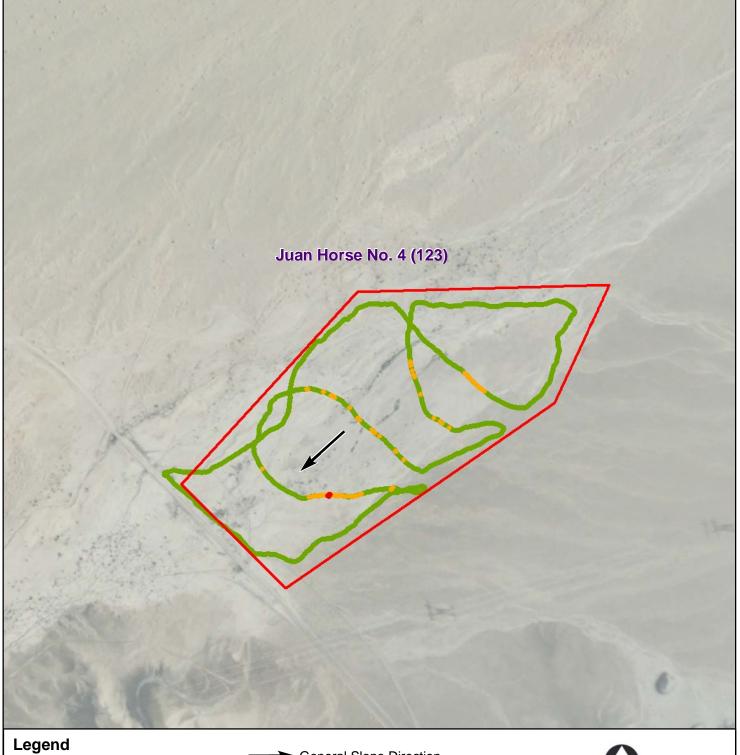
Figure 2 - Gamma Radiation Measurements Juan Horse No. 4 (123) Coalmine Mesa Chapter, Navajo Nation

A total of 1,999 gamma radiation measurements were collected from the mine site, ranging from 10,203 cpm to 26,792 cpm. The measurements are represented in Figures 1 and 2.
